Appendix 4 – Proactive turbidity reduction measures – Best Environmental Practice Techniques.

Best Environmental Practice (BEP) Techniques were established within the DSDMP to proactively reduce environmental impacts from the Pluto LNG Project dredging program. Table 1 identified each BEP and demonstrates compliance.

Table 1: Best Environmental Practice Water Quality Mangement Measures.

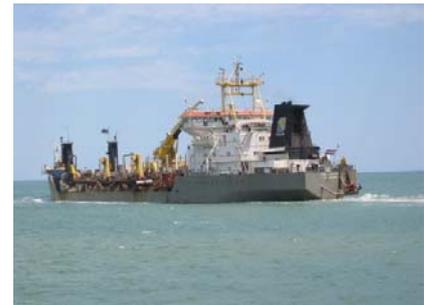
Vessel: "Cornelis Zanen"

Name of the Rep: Gary Edwards
Day of Activities: Wednesday 6th February 2008

- No. Loads: 5
- Average cycle time: 4.3 hours approximately.
- Est. insitu quantity today: 24,383 m³.
- Est. insitu quantity to date: 1,601,283 m³
- Material: The hopper loads are crushed material from the basin
- Dredging area: Turning basin (crushed)
- Work method: Dredging to economic load with hopper overflowing.
- Delays: none

- This is conducted by visually observing the dredging plume. The most concentrated plume is over the dredging area in the turning basin, caused primarily from the overflow and secondly from the propeller wash and crushing operations by Phoenix. The plume generally drifts in the direction of the current and dissipates after about 600m.
- At the disposal area the plume remains in the area where the load is released.

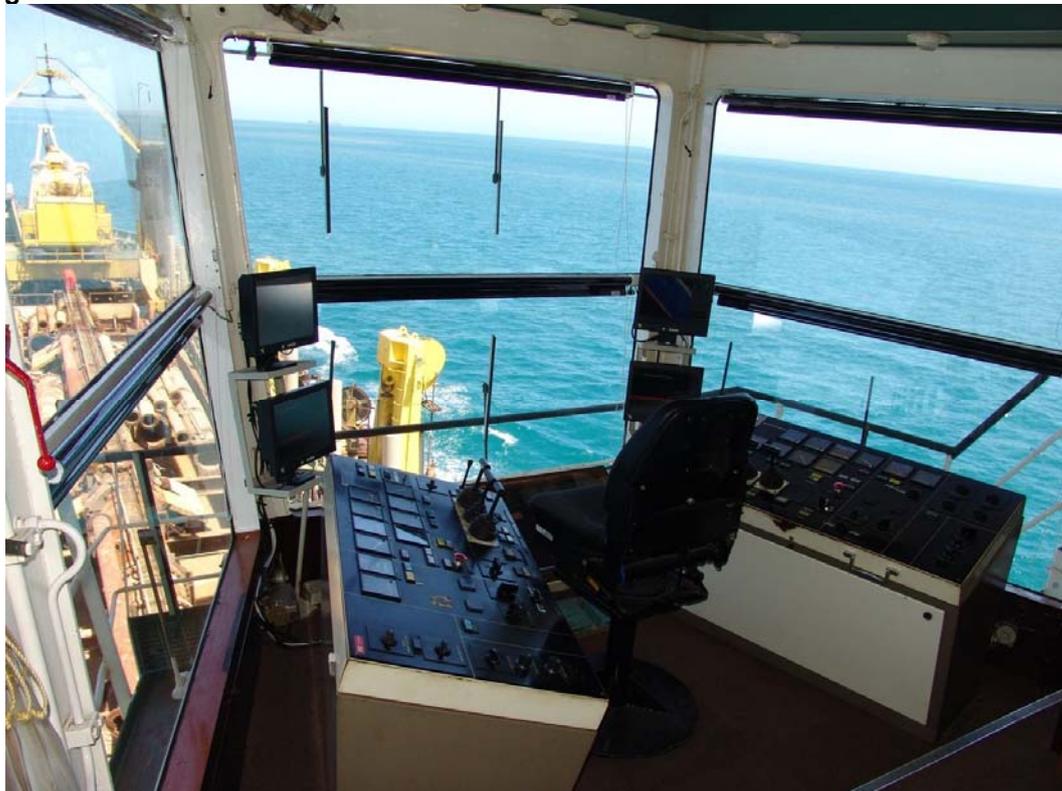
Figure 7. BEP#09:

Description:
Drag head control onboard the Coza during sailing.

BEP#08	Visualisation/ evaluation of dredged tracks/profiles/zones	- Regular track plots to be provided by contractor and analysed to ensure optimum methods are used so that no dredging outside the required area occurs	Allows effective management of operations to minimise impact	Vessel track plots	During all dredging and disposal activities with all dredging vessels	Regular bathymetric, cross sections and trailer dredger track plots were provided by the contractor from every survey undertaken and analysed by the Woodside Resident Dredging Engineer to ensure optimum methods were used so that no dredging outside the required area occurs. Refer to Figures 1, 2, and 14 for example track plots. Weekly track plots for the entire dredging program are available if required.	Figure 1 Figure 2 Figure 14
BEP#09	Online measurement of: - mixture velocity; - mixture concentration; - vessel heading, speed; - dredge production.	- Modern, fully equipped dredging vessels which include these features as standard will be utilised.	Improves operational efficiency leading to increased production and decreasing the duration of dredging	Vessel specification	During all dredging and disposal activities with all dredging vessels	Modern, fully equipped dredgers that include all of these features as standard were deployed during Phase 1. The presence and function of these systems was verified in pre-start audits by Woodside personnel. General photographs showing the operation of this equipment on the bridge of the Coza TSHD are provided in Figures 7-9.	Figure 7 Figure 8 Figure 9

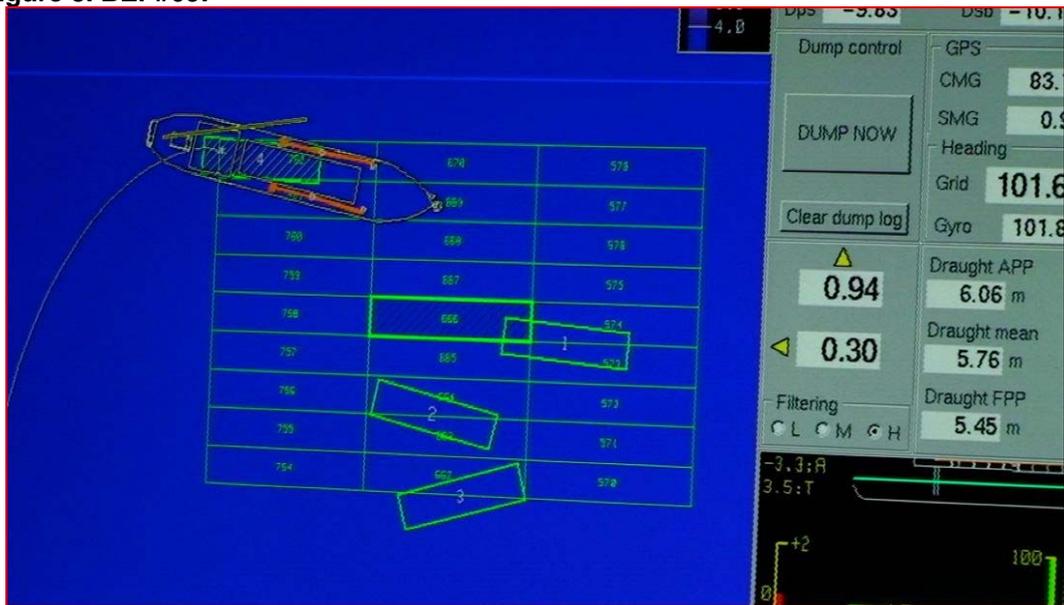
Figure 8. BEP#09:

Navigation/dredging screen onboard the 'Cornelis Zanen' during dumping of the 4th load into the North East corner of Spoil Ground 2B following commencement of Phase 1 dredging. The spoil ground is split into a total of approximately 3615 "dump boxes" to allow a dumping pattern to be planned. The "dump boxes" shown in this figure represent only those in the target area of the ground during this cycle.

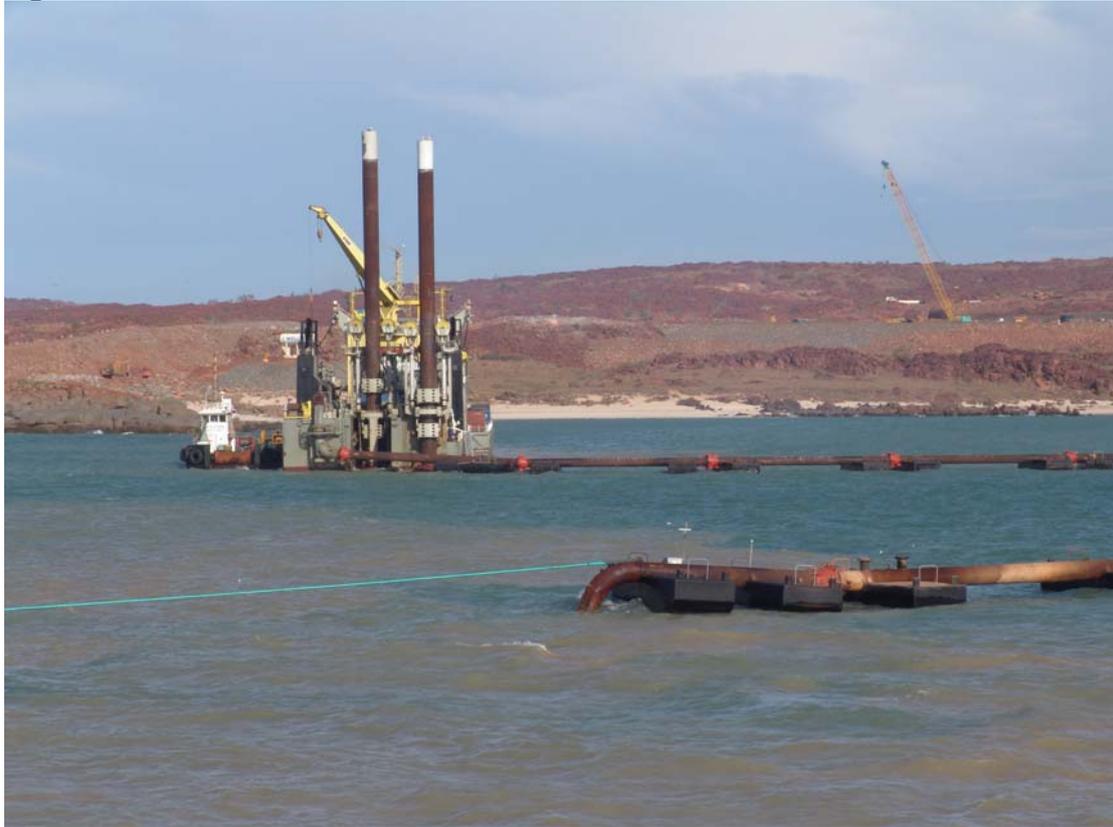
Figure 10. BEP#10:

CSD floating pipeline in use as the CSD 'Phoenix' operates in the turning basin. The pipeline was directed approximately 5 metres below the surface at this right angle junction, and relocated periodically to allow the TSHD 'Cornelis Zanen' to recover the spoil. A diffuser plate was fitted at the end of the pipeline (below the surface of the water) in order to reduce the velocity of the spoil/water mixture exiting the pipeline.

BEP#24	Ensure optimum timing of works with respect to sea and meteorological conditions	Relocate the TSHD away from the turning basin during periods of flood tides combined with sustained westerly winds in excess of 15knots.	Lowers potential impact of sediment plume from turning basin works on fringing corals	Track plots	During times where flood tides combine with sustained westerly winds.	Dispersion of turbidity plume from dredging works in the Turning Basin and its approached continually monitored. TSHD 'Cornelis Zanen' was deployed to the entrance channel as appropriate to minimise the spread of turbidity to the north from the Turning Basin. Evidence of the adequacy of turbidity management measures in Zone A is provided in Appendix 8. Monitoring has shown no loss in coral cover within Zone A.	N/A
BEP#25	Minimise the abrasion path while crushing soft rock	Minimise transport distance during pumping of soft rock	Limits creation of rock flour	Contractors Method Statement	During all pumping activities with the CSD	Floating pipeline was only used with CSD when water depth limited trailer dredger operations in the Turning Basin area. The bulk of the crushing of calcareous materials was done with no pumping by CSD dredger at all (i.e. crush in situ with recovery by TSHD). When pipeline was required, a short length of approximately 300m was utilised. The CSD 'Phoenix' was found to generate minimal 'rock flour' due to its high power cutting action therefore large fragments of rock were fractured rather than a grinding action which is known to create a smaller particle size. This was discussed during DEMG meeting 4.	Figure 10

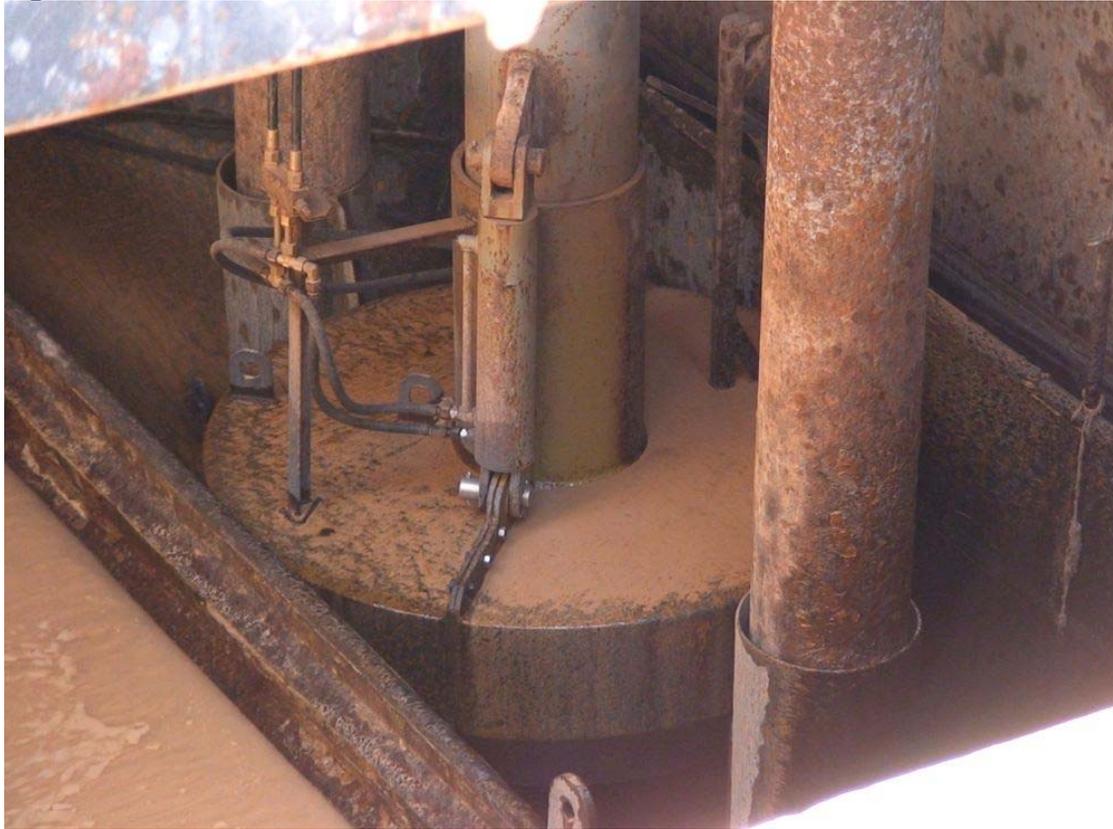
Figure 11. BEP#11:

Description:
Anti turbidity valve fitted in the hopper of the TSHD 'Cornelis Zanen'.

BEP#10	Use of submerged diffuser to place spoil low in water column to reduce velocity of mixture	- Diffuser to be used when CSD side casting via a pipeline	Ensure material is released as close as possible to the seabed, leading to less solids entering the water column and significantly lower settlement times	Contractors Method Statement	During all CSD side casting activities	Sidecasting via pipeline was required on one occasion during Phase 1 when the CSD 'Phoenix' was cutting in the JEZ and casting behind for recovery by the 'Cornelis Zanen'. During this period, a diffuser was used in order to deposit cut material as close to the bottom as possible, thus reducing the dispersion potential and extent of the plume. A photograph of the diffuser in operation is provided in Attachment 10.	Figure 10
BEP#11	Adjustable anti-turbidity overflow shaft	- Anti-turbidity valve in overflow shaft to be utilised on TSHD	Lowers the intensity, duration and spatial extent of the turbidity plume	Vessel specification	During all TSHD dredging activities	TSHD 'Cornelis Zanen' is fitted with an anti-turbidity valve in the hopper overflow. The anti-turbidity valve was always used.	Figure 11

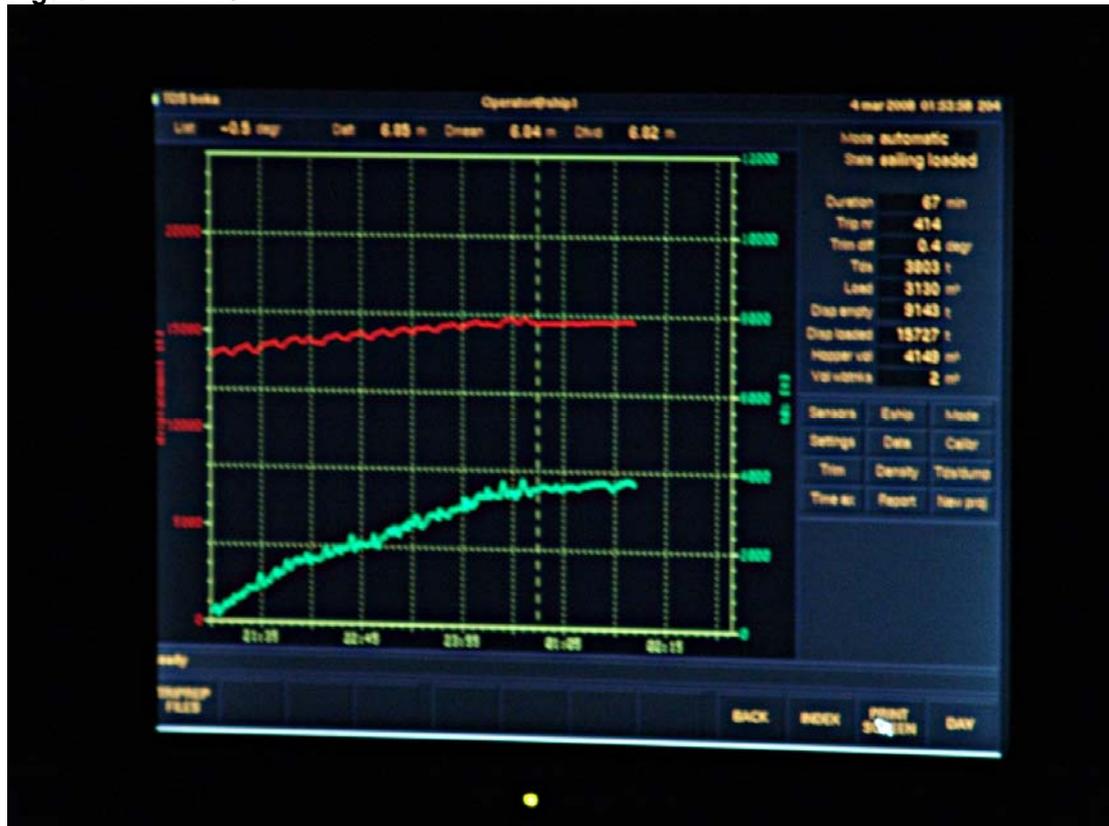
Figure 12. BEP#13:

Real-time dredge management system with loading chart displayed. The vertical dashed line indicates the optimal load point where additional overflow time will not result in significantly improved load size. This photograph demonstrates that following the optimal loading point being reached, the 'Cornelis Zanen' has ceased dredging and departed for the spoil ground (status in the top right corner of the photograph is set to "sailing loaded").

BEP#12	Submerged Dredge Pumps	- To be utilised on CSD; - No benefit for TSHD at required dredging depths	Improves operational efficiency leading to increased production and decreasing the duration of dredging	Vessel specifications	During all CSD dredging works	Cutter dredger Phoenix is built with a ladder pump. The pump cannot be bypassed.	N/A
BEP# 13	Establish optimum overflow time for the TSHD using loading diagrams	- Loading charts / data to be used by contractor to establish optimum overflow times; - Loading charts / data to be provided by contractor for analysis	Improve operational efficiency leading to increased production and decreasing the duration of dredging	Loading charts	Optimisation of the overflow process will be an ongoing process throughout the TSHD dredging activities. As the project proceeds, the data available from the monitoring programs will also be applied to the overflow optimisation process. In the event that conditions where overflow causes unacceptable impacts on benthic habitats are identified, overflow will be reduced or eliminated when dredging in similar condition during the remainder of the works.	TSHD 'Cornelis Zanen' was always loaded for optimal dredging efficiency during Phase 1. Whilst a loading chart was available, loading phase of dredge cycle optimisation provided by onboard, real time dredge management system. The system alerts the operator once the optimum load has been reached (i.e. the mass loaded plateaus), dredging ceases, and the dredge departs for the dump site.	Figure 12

BEP# 14	Minimal Overflow for bulk dredging of low density / high moisture content sediments by the TSHD	- Contractor to dredge with minimal overflow when bulk dredging low density/high moisture content sediments	Reduces introduction of sediments into water column	Loading charts	During all dredging of low density / high moisture content sediments by the TSHD. Also see BEP #13	Trailer dredger Cornelis Zanen was always loaded for optimal dredging efficiency. Loading phase of dredge cycle optimisation provided by onboard, real time dredge management system thereby minimising discharge of fine fractions from the hopper (Figure 12). A daily report for 22 November 2007 (first day of dredging) documenting the use of minimal/no overflow during dredging of fine silt is provided in Figure 13.	Figure 12 Figure 13

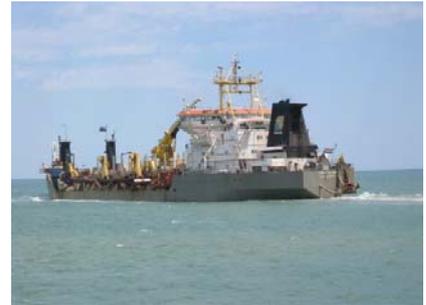
Vessel: "Cornelis Zanen"

Name of the Rep: Ron Hutchinson
Day of Activities: Thursday 22nd November 2007

- No. Loads 5 between 7:50 am and 24:00 average cycle time approx 3.5 hours;
- Est. quantity (insitu) 16,500 m³;
- Vessel loading with post-overflow time of 0 to 5 minutes. Overflow time will increase as sand and gravel component increases;
- Material: silt, silty fine sand, occasional gravel;
- Dredging area Turning Basin Pit excavation.

- Turbidity plumes generally 200m by 200m hugging coast on flooding tide and decayed plumes evident 2 hours later in both dredging and spoil ground. Plumes from previous loads decayed during ebbing tides and not obvious after 2 hours;
- Plumes generation is from propeller action in shallow water.
